**ANALYSIS OF BROWNFIELD CLEANUP ALTERNATIVES**

**MIFCO Environmental Recycling, Inc. – Old Book Bindery**

516 South Wayne Street  
Portland, Jay County, Indiana  
BFD# 4170703  
CA# BF-00E48101-B

July 2019

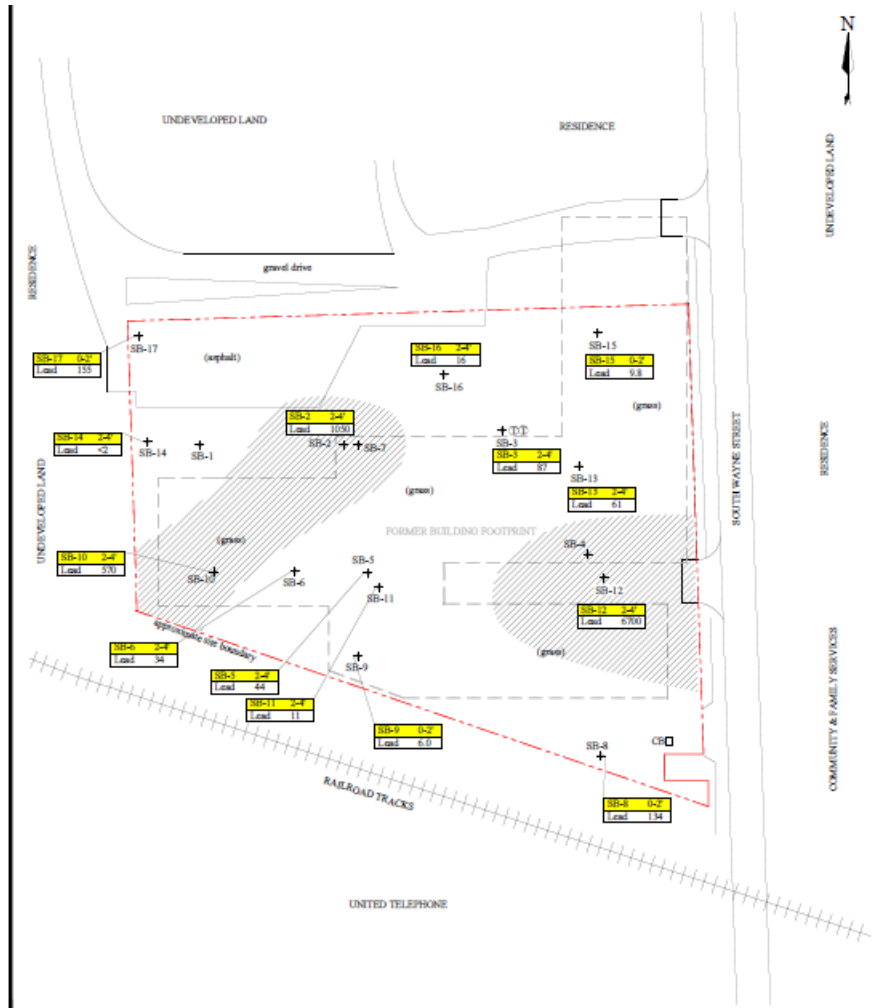
- Lead concentrations in fill soil samples SB-2 (2-4), SB-10 (2-4), and SB-12 (2-4) exceed the *residential direct contact screening level*. Lead concentrations in fill soil samples SB-2 (2-4) and SB-12 (2-4) exceed the *commercial/industrial direct contact screening level*. Lead concentrations in fill soils are depicted in the Figures in Appendix A. Investigation found no evidence of impact extending into the native soils beneath the surface fill.

Lead is the only parameter that exhibits concentrations exceeding the *residential direct contact screening level*. Specifically, lead concentrations in surface fill soil samples SB2 (2-4), SB10 (2-4), and SB12 (2-4) exceed screening levels.

- Based on comparison of soil testing results to RDCSLs, corrective action and remediation should focus on the areas of SB2, SB10, and SB12. See Appendix A where this affected area is shown.

This ABCA determined that while there may be alternatives for addressing contamination at this particular site, given the known conditions and proposed redevelopment, extraction would be the most effective corrective action alternative to achieve closure without restrictions.
