# *Indiana* TOLL ROAD

January 2021 to December 2021

# ANNUAL STATE OF THE ITR REPORT

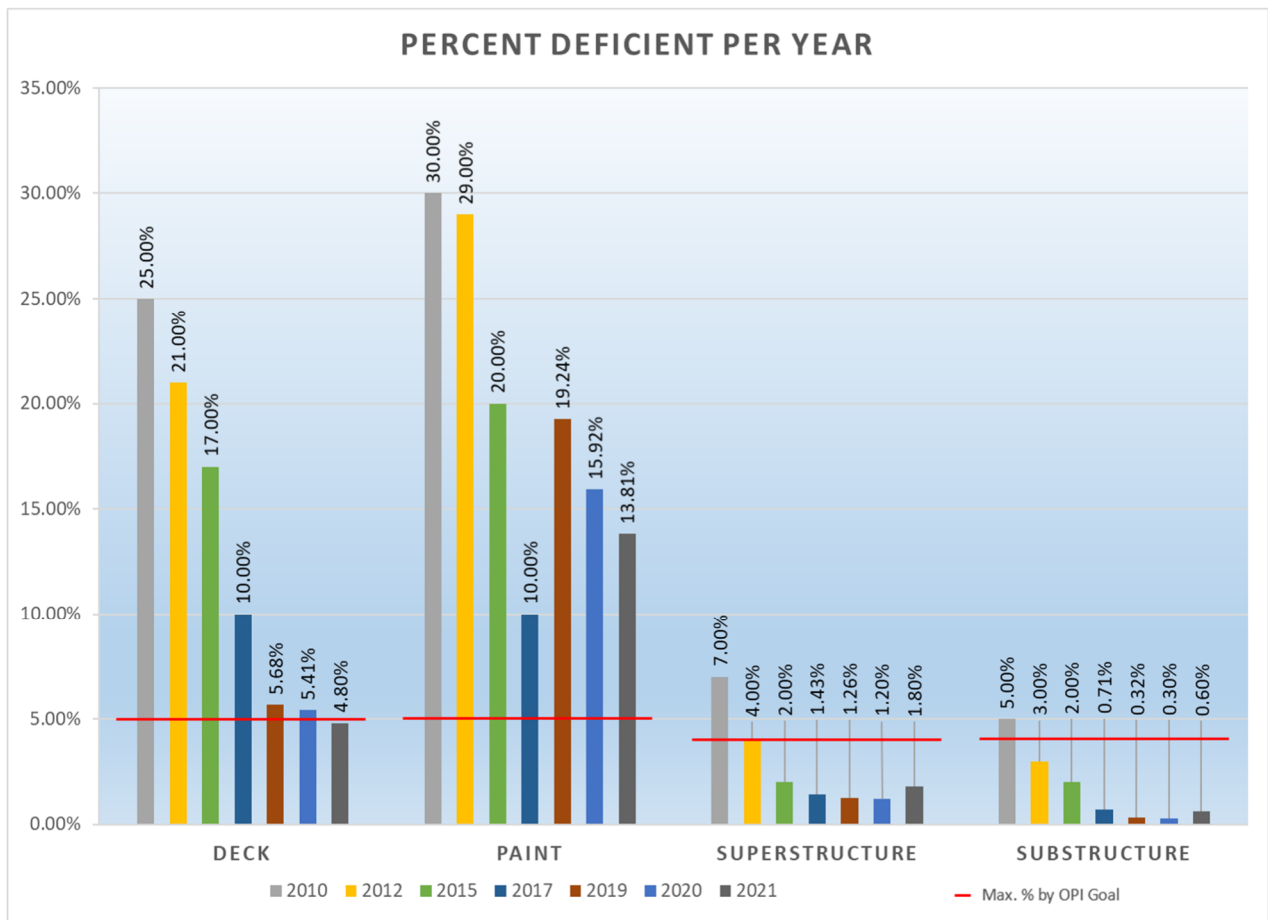
Figure 1.1: Bridge Condition Ratings

The 2021 inspections for the state of the ITR structures has maintained relatively consistent with the 2020 inspection data. There were minor increases to the Wearing Surface, Superstructure, and Substructure deficiency ratings, while lower deficiency ratings were reported for the Deck and Paint. PUSH 3, was delivered in 2021 which included six bridge deck replacements with bridge widening, two bridge deck overlays, nine structures with substructure patching and joint replacement, and bridge paintings on multiple structures.

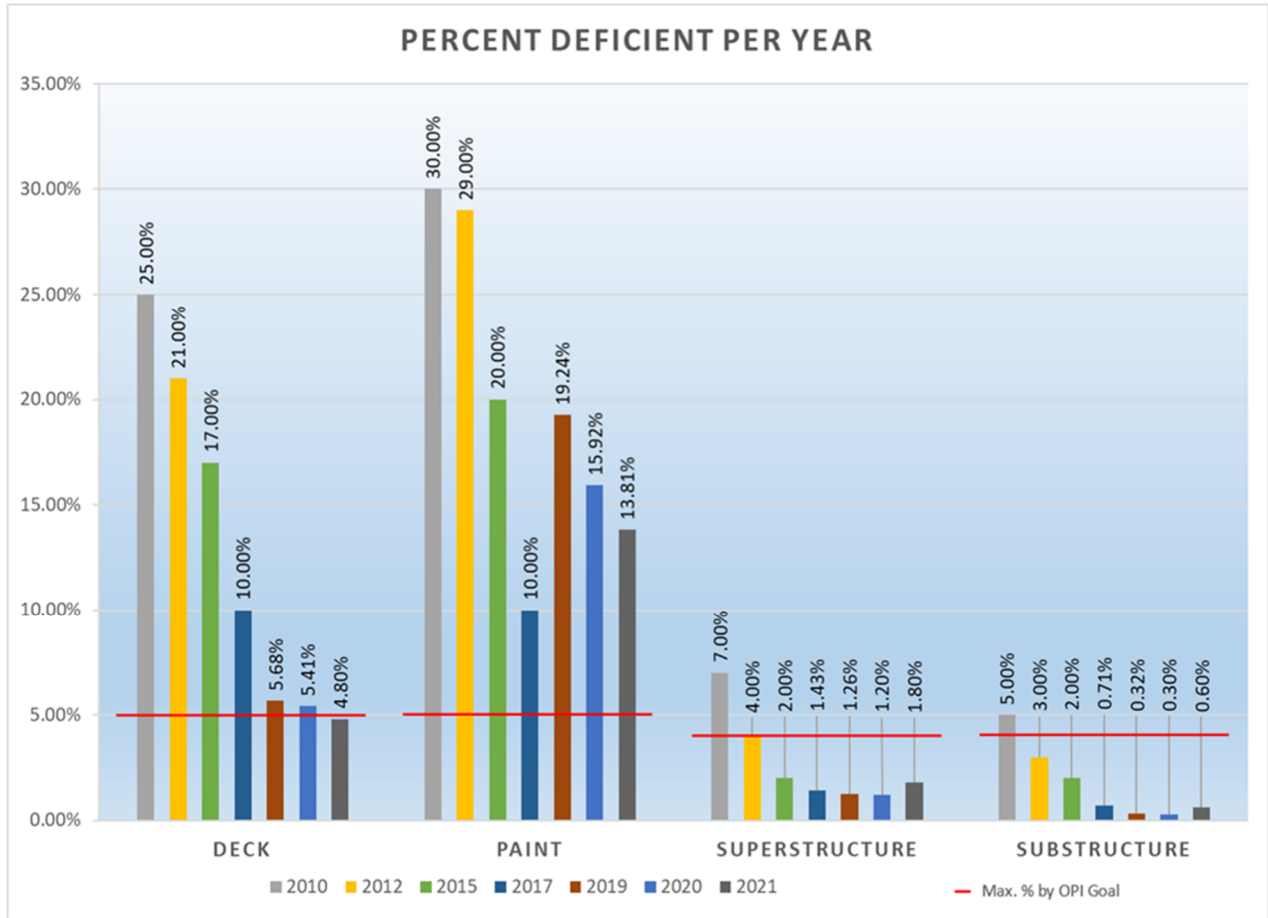
Figure 3.1: Bridge Condition Ratings

**Figure 3.1: Bridge Condition Ratings** illustrates that there has been an overall slight increase in deficiencies in several of the individual items compared to previous years. Decreases in deficiencies for Deck and Paint are due to the implementation of the PUSH projects and additional job order contracts. The three phases of PUSH have addressed over 25% of the structures within the ITR corridor.

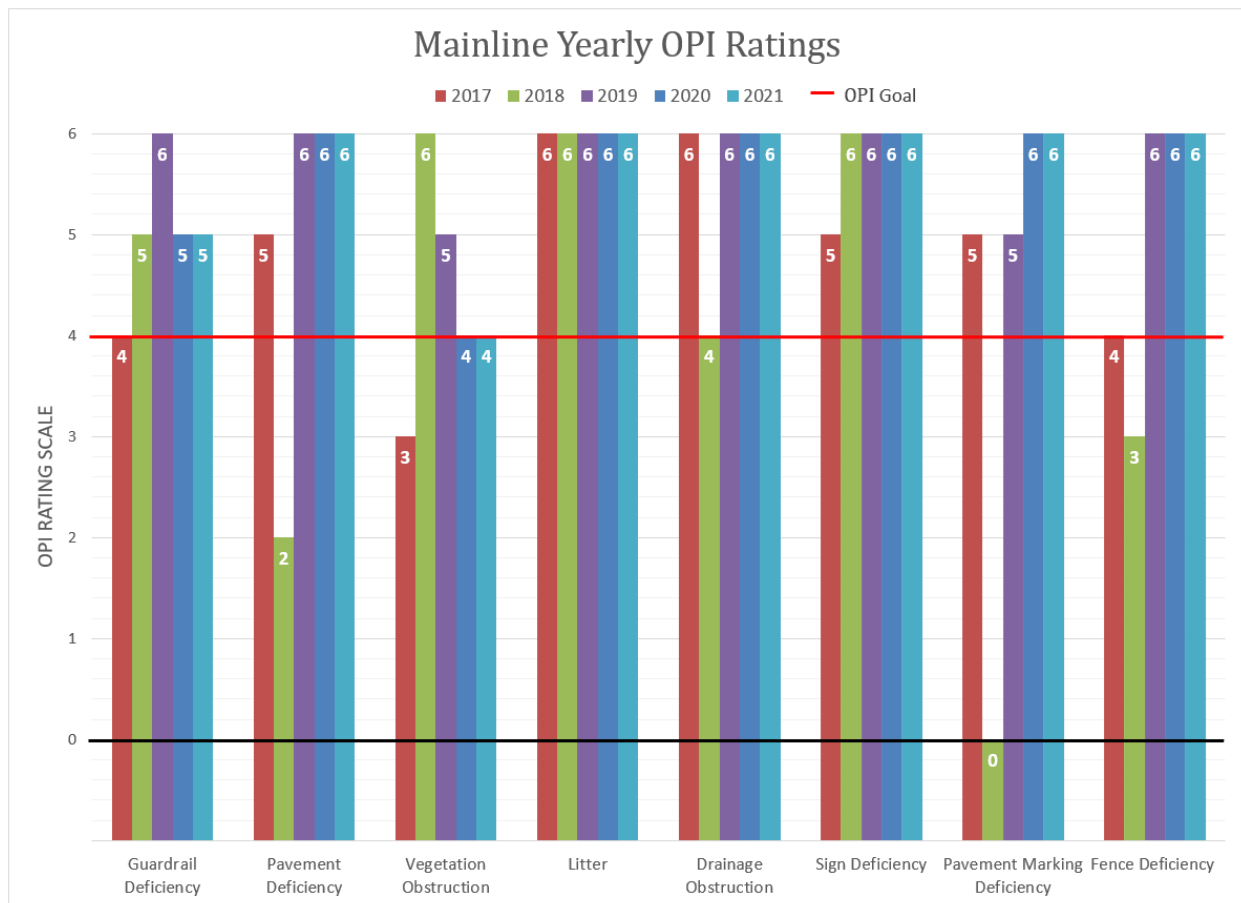
Figure 5.1: Mainline Yearly OPI Ratings

**Table 5.2: Mainline Maintenance Items for ITR** provides the total accumulated deficiencies for the entirety of the mainline. **Tables 5.3 – 5.7**, located in Appendix E, represent each maintenance district and list the number of deficiencies, deficiency rates, and OPI ratings for the eight mainline maintenance items. The ratings range from 0 to 6, with 6 being the highest. **Figure 5.1: Mainline Yearly OPI Ratings** illustrates the mainline maintenance OPI rating progression over the past four years in comparison to the 2021 ratings.

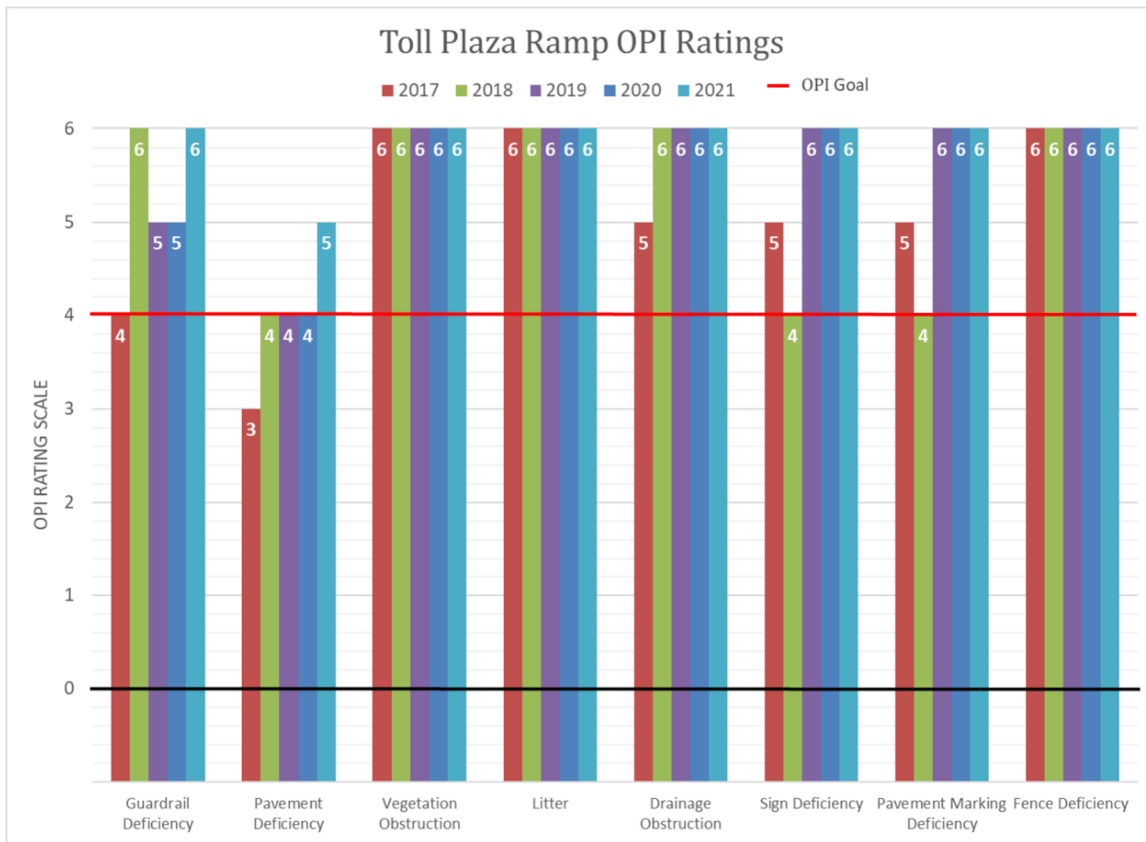
Figure 5.2: Toll Plaza Ramp OPI Ratings

**Table 5.8: Toll Plaza Maintenance Items for ITR** provides the total accumulated deficiencies for the entirety of the toll plazas. **Tables 5.9 – 5.13**, located in Appendix E, represent each maintenance district and list the number of deficiencies, deficiency rates, and OPI ratings for the eight toll plaza maintenance items. The ratings range from 0 to 6, with 6 being the highest. **Figure 5.2: Toll Plaza Ramp OPI Ratings** (located below) illustrates the Toll Plaza Ramp Maintenance OPI rating progression over the past four years in comparison to the 2021 ratings.

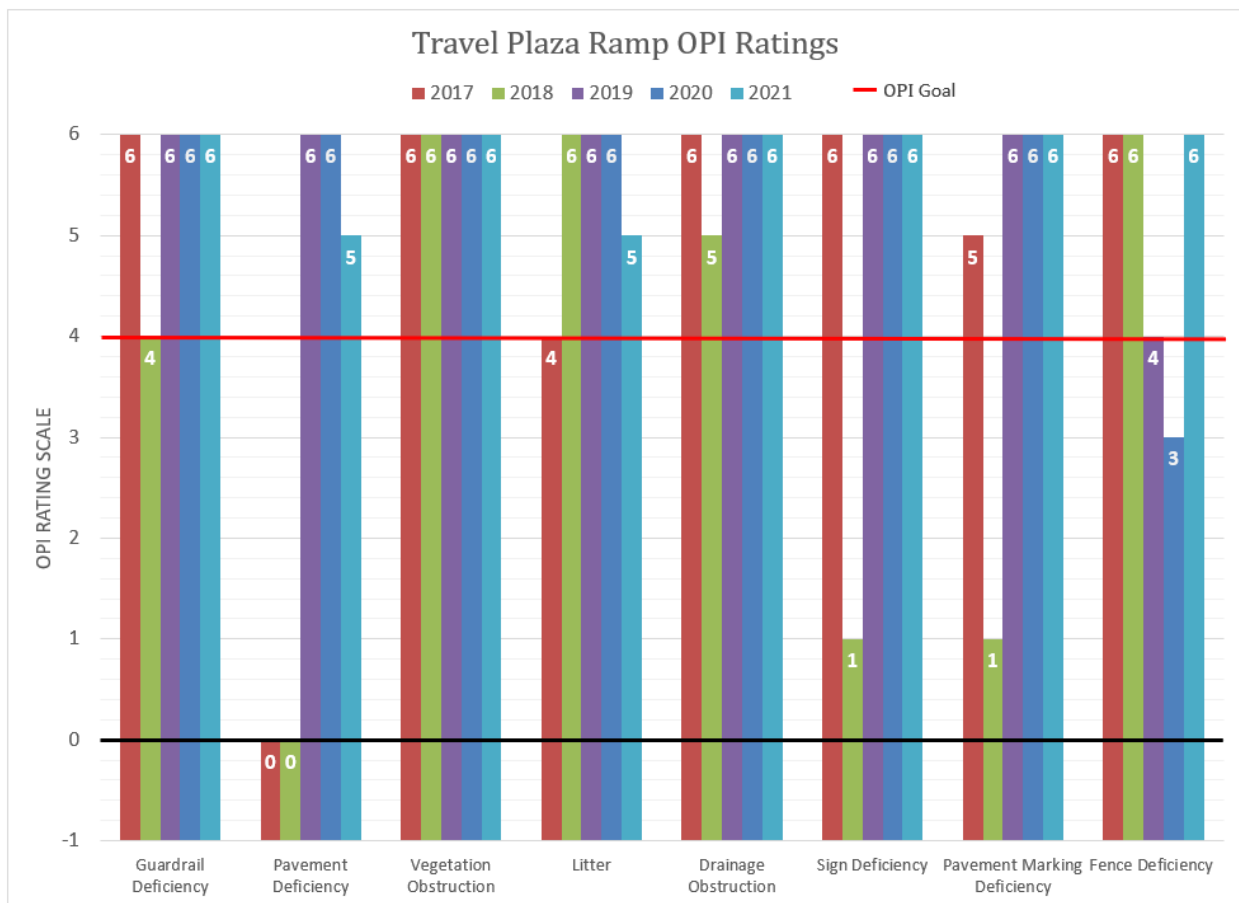
Table 5.14: Travel Plaza and Truck Parking Maintenance Items for ITR provides the total accumulated deficiencies for the entirety of the travel plazas. Tables 5.15 – 5.19, located in Appendix E, represent each maintenance district and list the number of deficiencies, deficiency rates, and OPI ratings for the eight travel plaza maintenance items. The ratings range from 0 to 6, with 6 being the highest. Figure 5.3: Travel Plaza Ramp OPI Ratings (located below) illustrates the Toll Plaza Ramp Maintenance OPI rating progression over the past four years in comparison to the 2021 ratings.
