indiana
TOLL ROAD

January 2022 to December 2022

ANNUAL STATE OF THE ITR REPORT

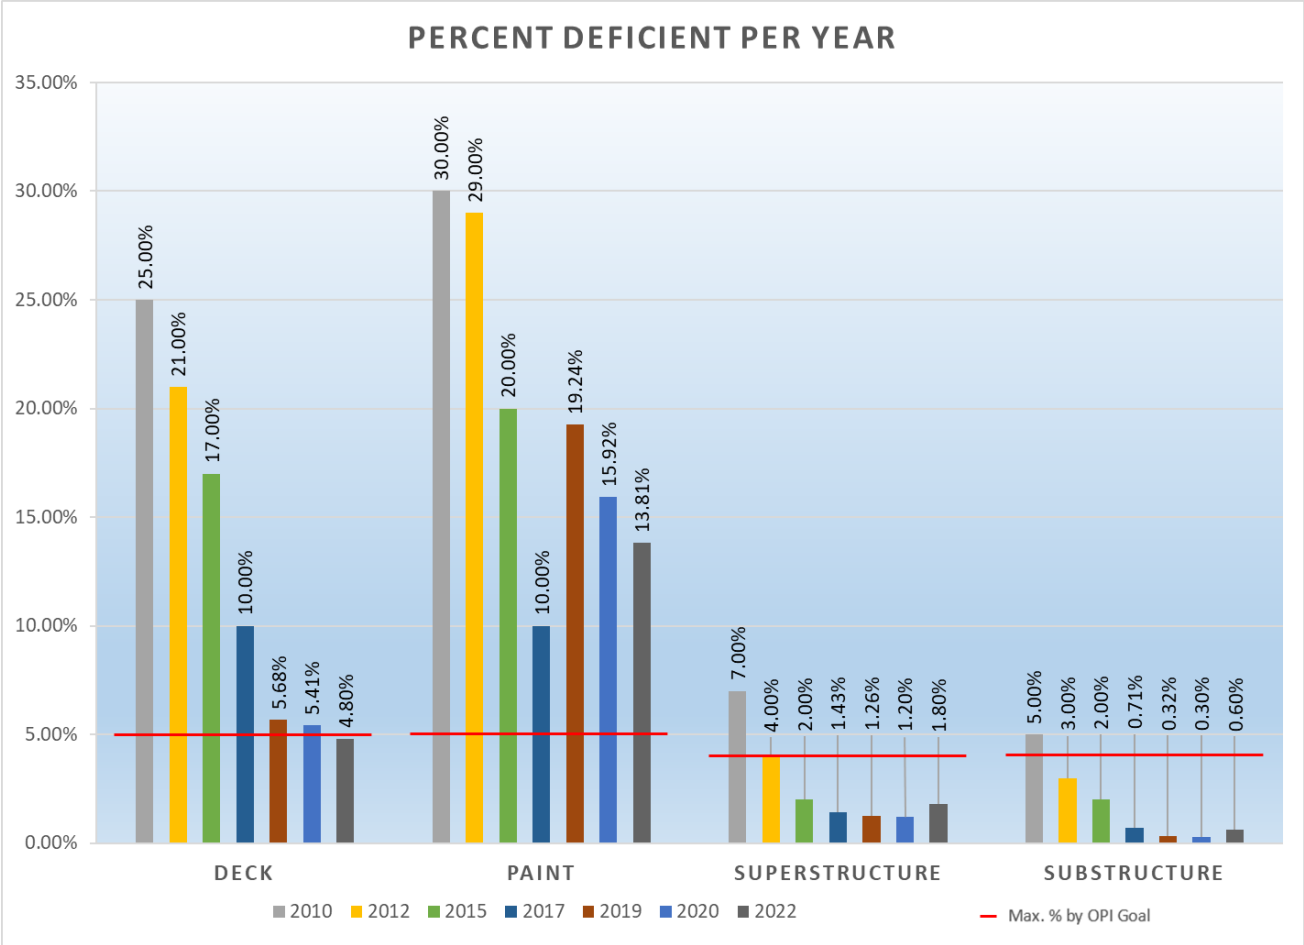
Figure 1.1: Bridge Condition Ratings

The 2022 inspections for the state of the ITR structures have maintained relatively consistent with the 2021 inspection data. A lower deficiency rating has been reported for the Wearing Surface, while ratings for the Deck, Paint, Superstructure, and Substructure have remained the same. PUSH 3.0 was delivered in 2021 and included six bridge deck replacements with bridge widening, two bridge deck overlays, nine structures with substructure patching and joint replacement, and bridge paintings on multiple structures.

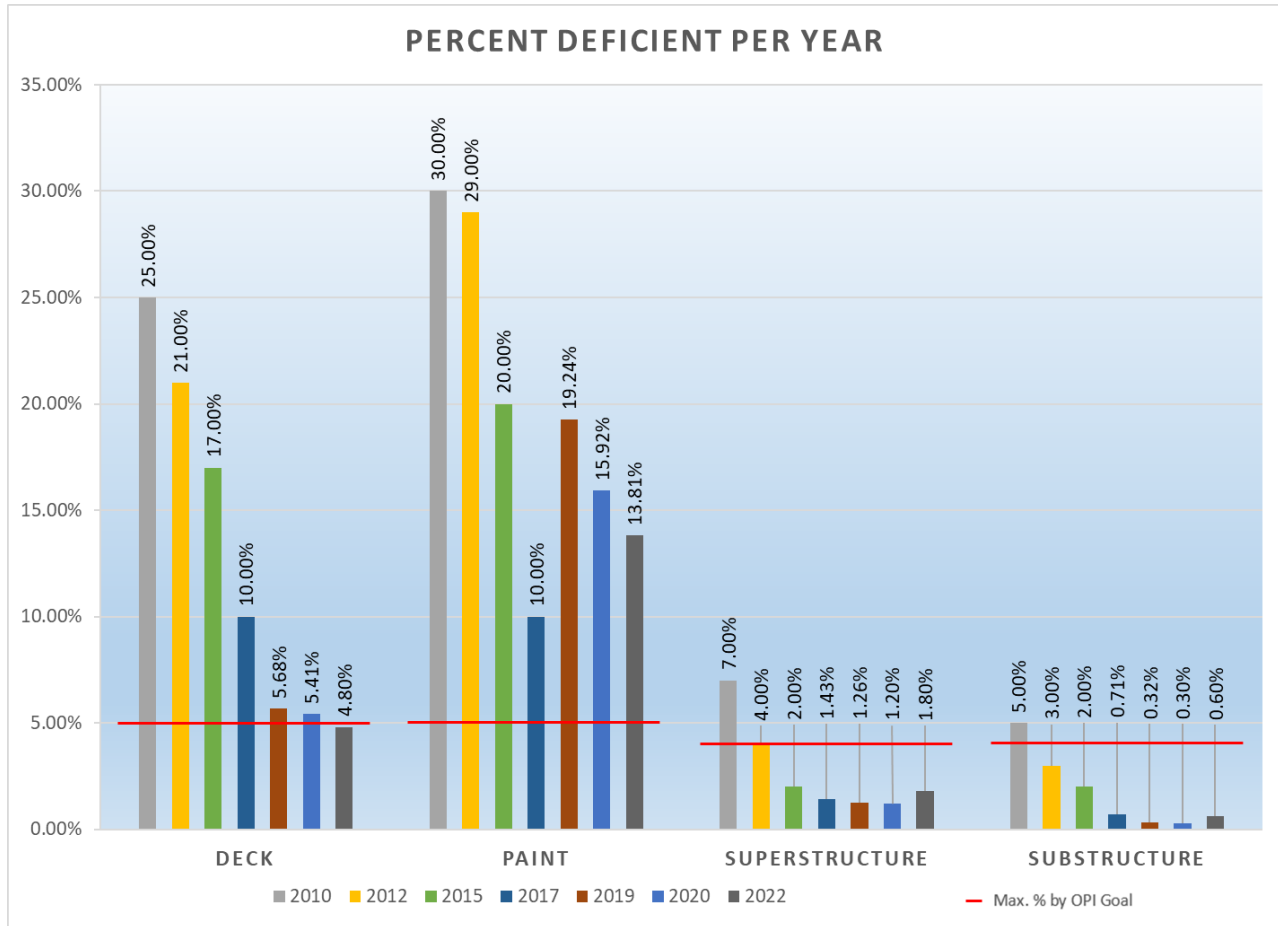
Figure 3.0: Bridge Condition Ratings illustrates that there has been an overall slight increase in deficiencies in several of the individual items compared to previous years. Decreases in deficiencies for Deck and Paint are due to the implementation of the PUSH projects and additional job order contracts. The three phases of PUSH have addressed over 25% of the structures within the ITR corridor.

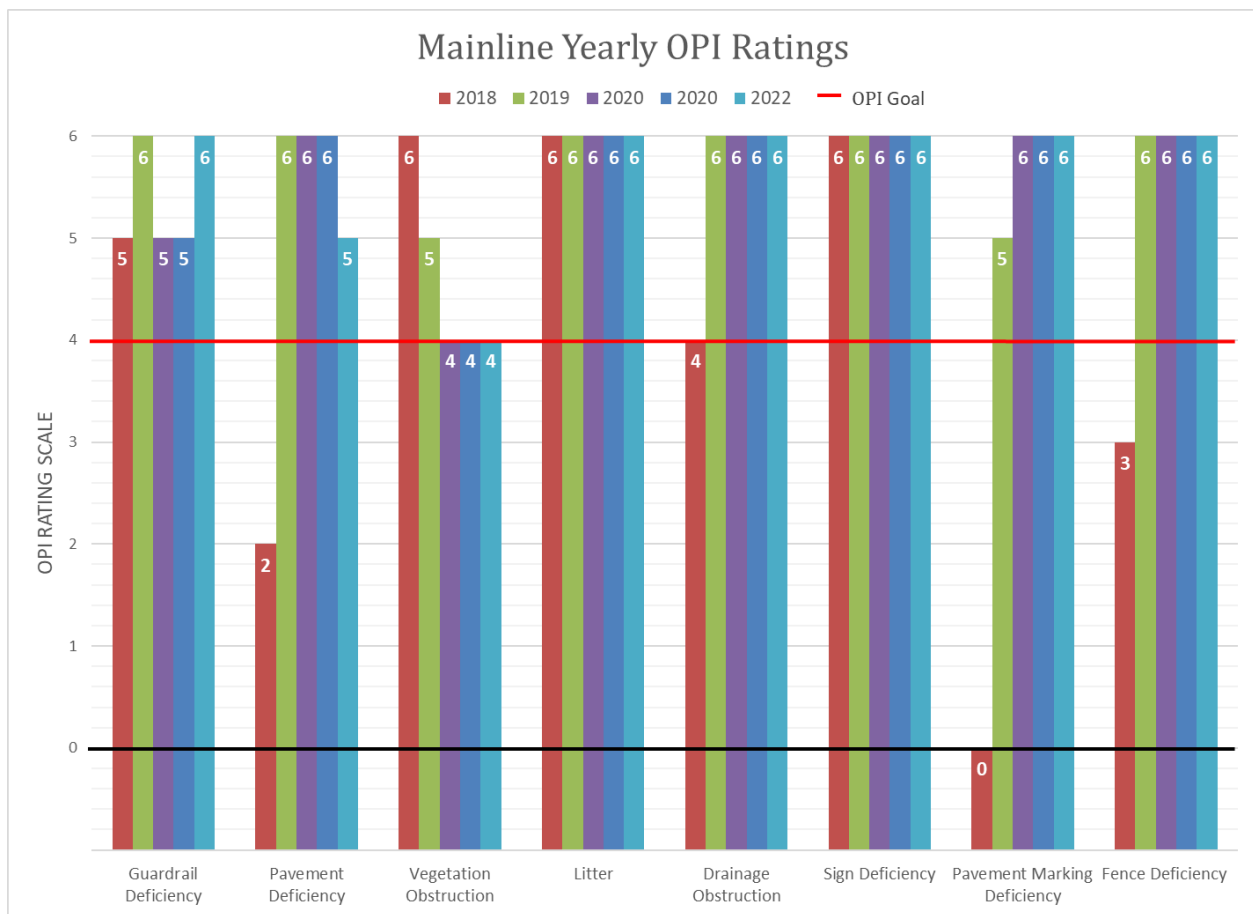
Figure 5.1: Mainline Yearly OPI Ratings

Table 5.2: Mainline Maintenance Items for ITR provides the total accumulated deficiencies for the entirety of the mainline. **Tables 5.3 – 5.7**, located in Appendix E, represent each maintenance district, and list the number of deficiencies, deficiency rates, and OPI ratings for the eight mainline maintenance items. The ratings range from 0 to 6, with 6 being the highest. **Figure 5.1: Mainline Yearly OPI Ratings** illustrates the mainline maintenance OPI rating progression over the past four years in comparison to the 2022 ratings.

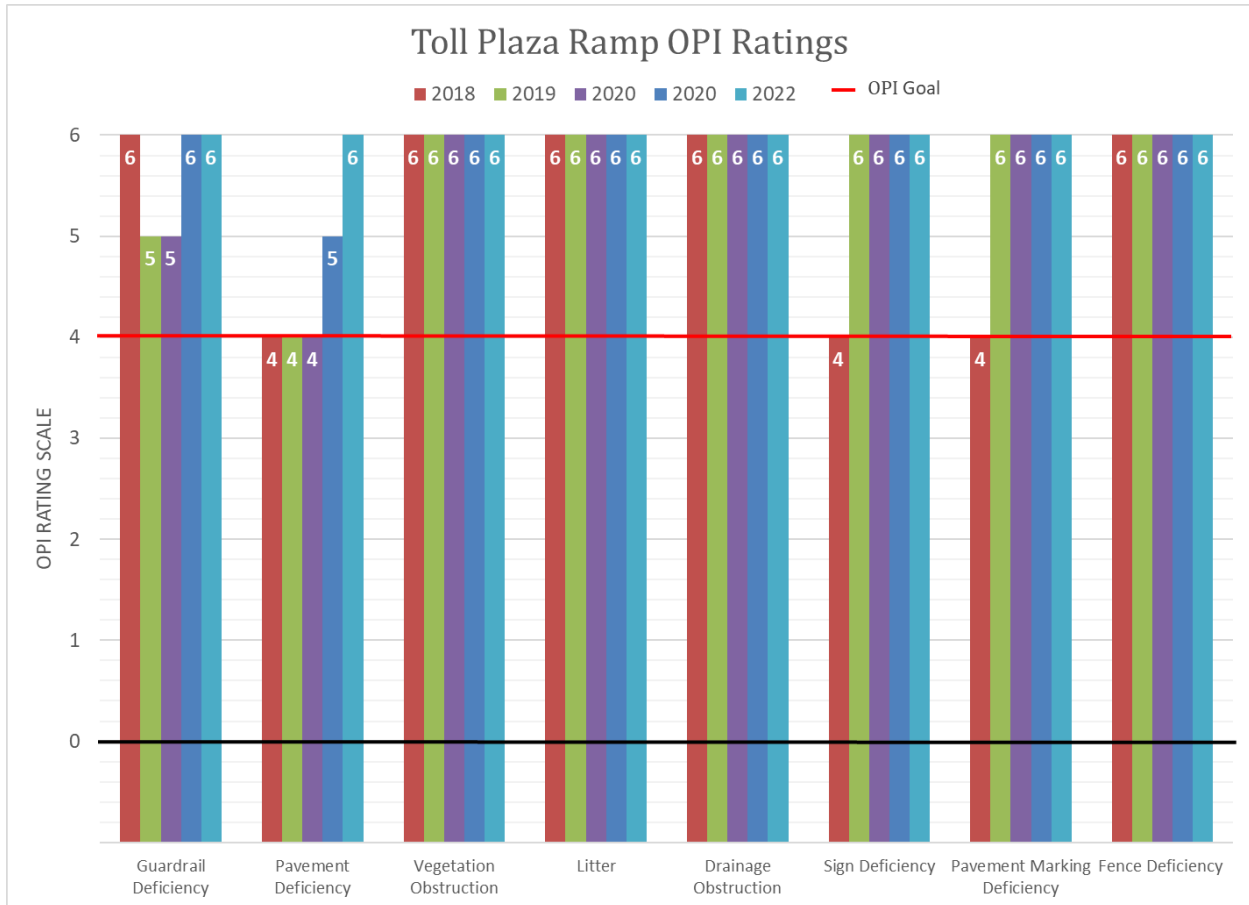
Figure 5.2: Toll Plaza Ramp OPI Ratings

Table 5.8: Toll Plaza Maintenance Items for ITR provides the total accumulated deficiencies for the entirety of the toll plazas. **Tables 5.9 – 5.13**, located in Appendix E, represent each maintenance district and list the number of deficiencies, deficiency rates, and OPI ratings for the eight toll plaza maintenance items. The ratings range from 0 to 6, with 6 being the highest. **Figure 5.2: Toll Plaza Ramp OPI Ratings** illustrates the Toll Plaza Ramp Maintenance OPI rating progression over the past four years in comparison to the 2022 ratings.

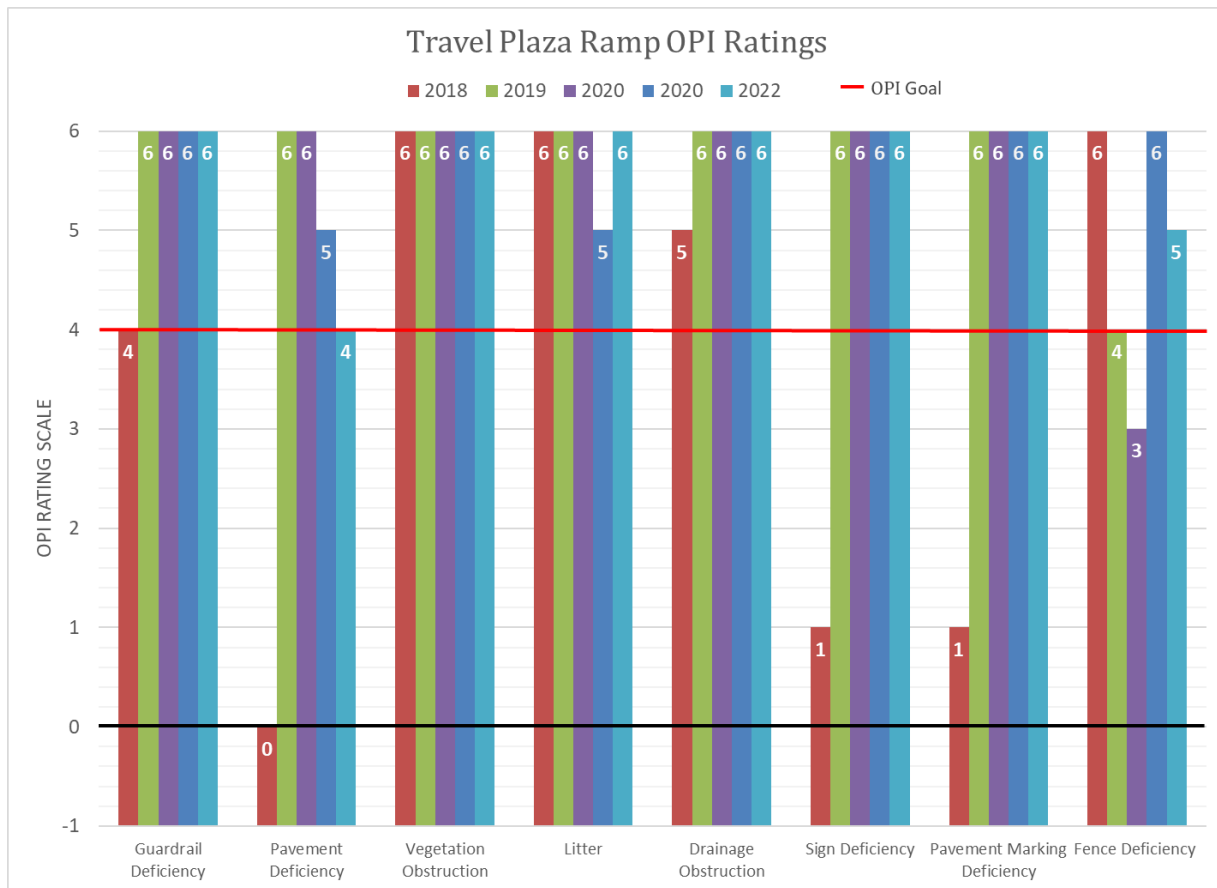
Figure 5.3: Travel Plaza Ramp OPI Ratings

Table 5.14: Travel Plaza and Truck Parking Maintenance Items for ITR provides the total accumulated deficiencies for the entirety of the travel plazas. **Tables 5.15 – 5.19**, located in Appendix E, represent each maintenance district, and list the number of deficiencies, deficiency rates, and OPI ratings for the eight travel plaza maintenance items. The ratings range from 0 to 6, with 6 being the highest. **Figure 5.3: Travel Plaza Ramp OPI Ratings** illustrates the Toll Plaza Ramp Maintenance OPI rating progression over the past four years in comparison to the 2022 ratings.

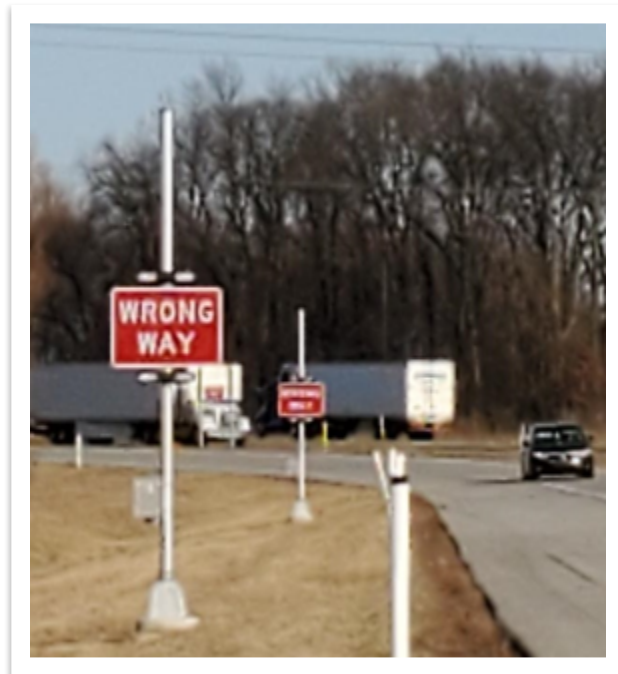
Image 5.1: Wrong Way Detection System

To increase both customer and worker safety, the ITRCC developed a plan to detect and prevent wrong-way drivers, as shown in **Image 5.1: Wrong Way Detection System**. The

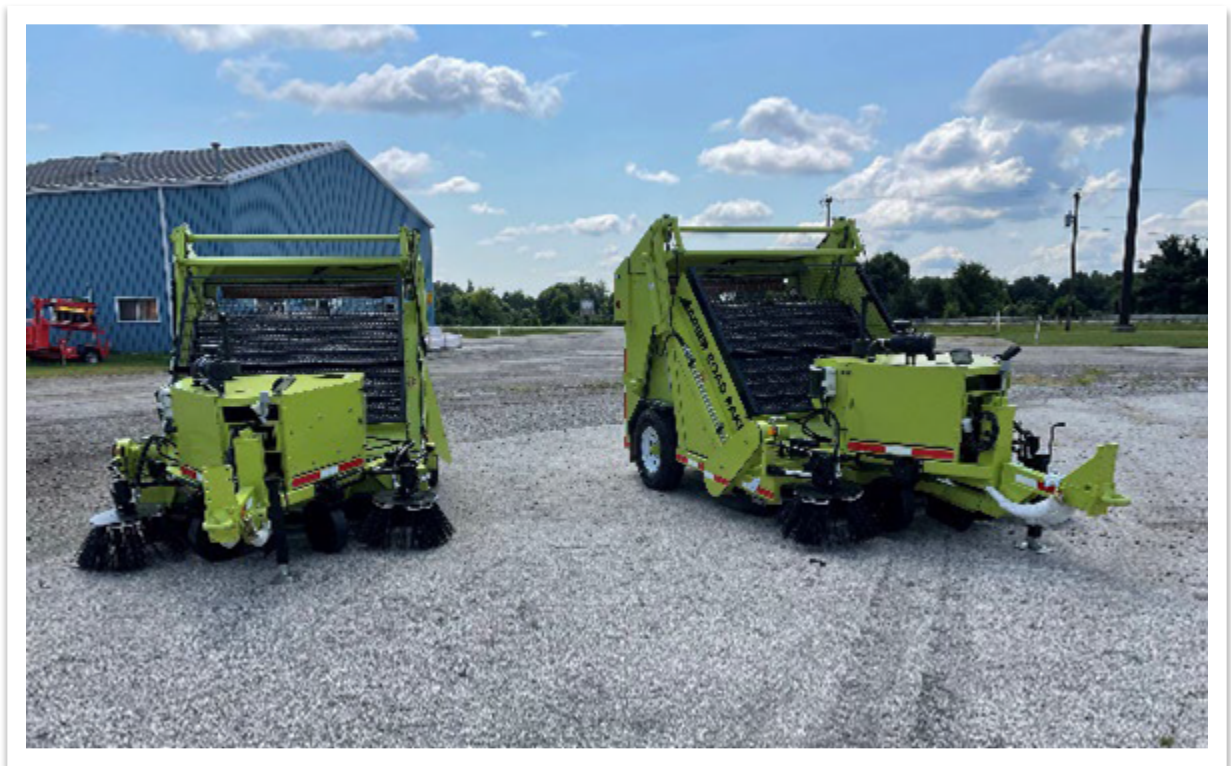
Image 5.2: Barber Road Rake

As part of the maintenance initiative, the ITRCC purchased two Model 200 Barber Road Rakes, as depicted in **Image 5.2: Barber Road Rake**. These two units, in conjunction with new policy and procedures, help keep the road clear of debris, keep employees and customers safe from debris and live traffic, and reduces the amount of time it takes to clean the mainline as well as travel/truck parking lots.
